**Residual Strength and Repair of Damaged and Deteriorated  
Offshore Structures**

**REPAIR OF DENTED TUBULAR COLUMNS -  
WHOLE COLUMN APPROACH**

By  
J.M. Ricles  
W.M. Bruin  
T.K. Sooi

ATLSS Report No. 97-13

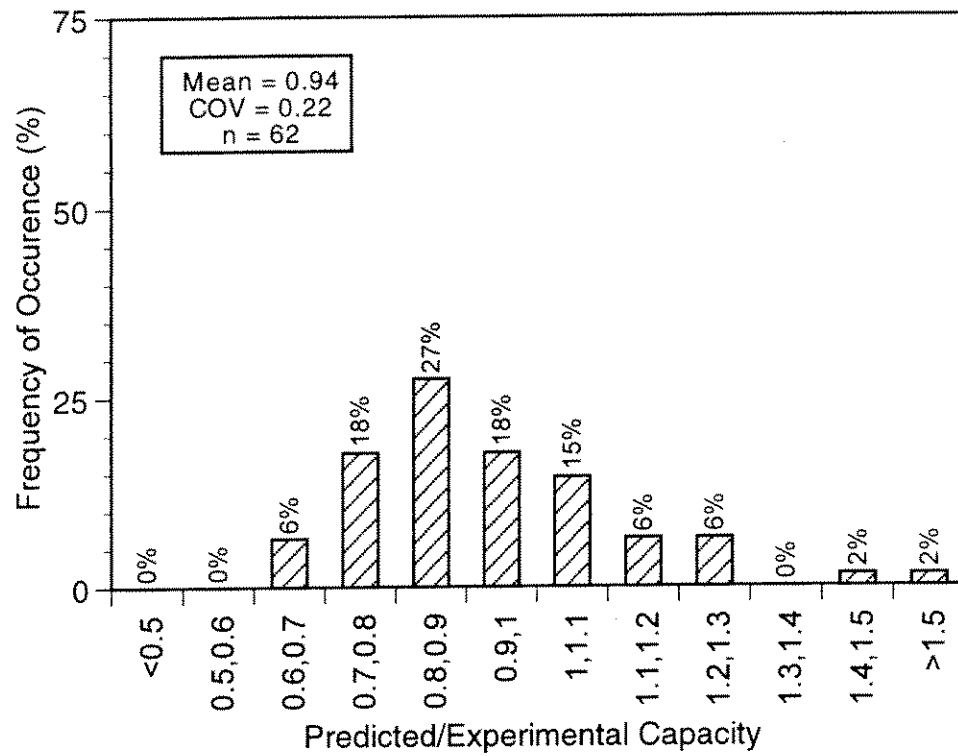
Figure 4.55 - Histogram of Predicted-to-Measured Capacity Ratio for Loh's Modified AISC-LRFD Equation (Includes Current and Previous Experimental Data)

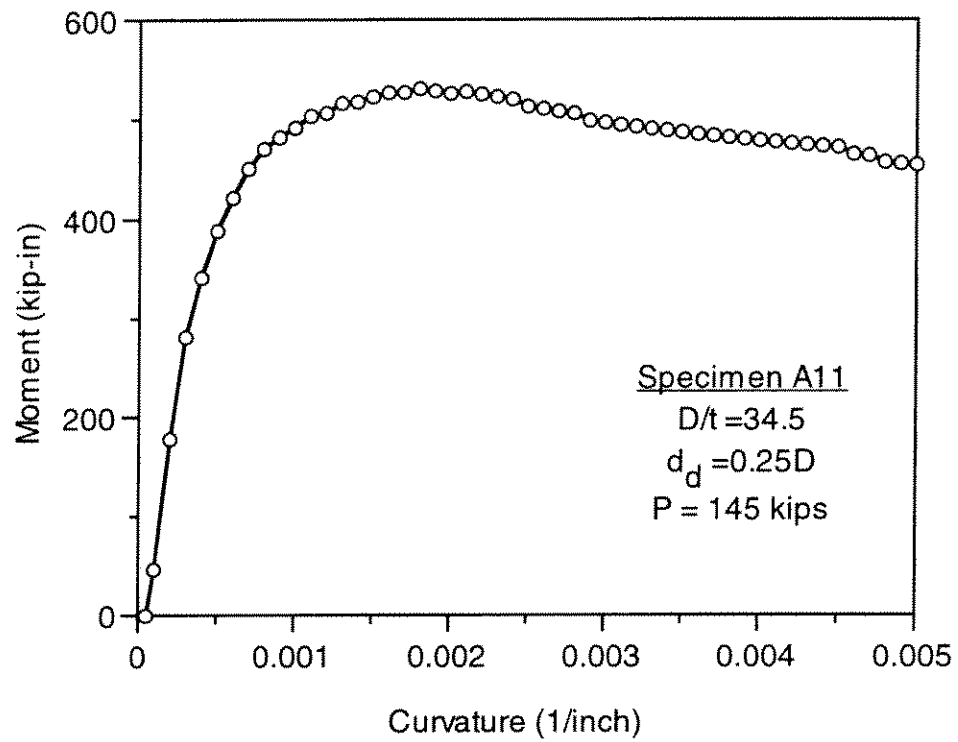
Figure 4.57 - Typical Moment-Curvature (M- $\phi$ ) Relationship for an Internal Grout Repaired Specimen (Moment Referenced at Centroid of Undented Cross-Section).

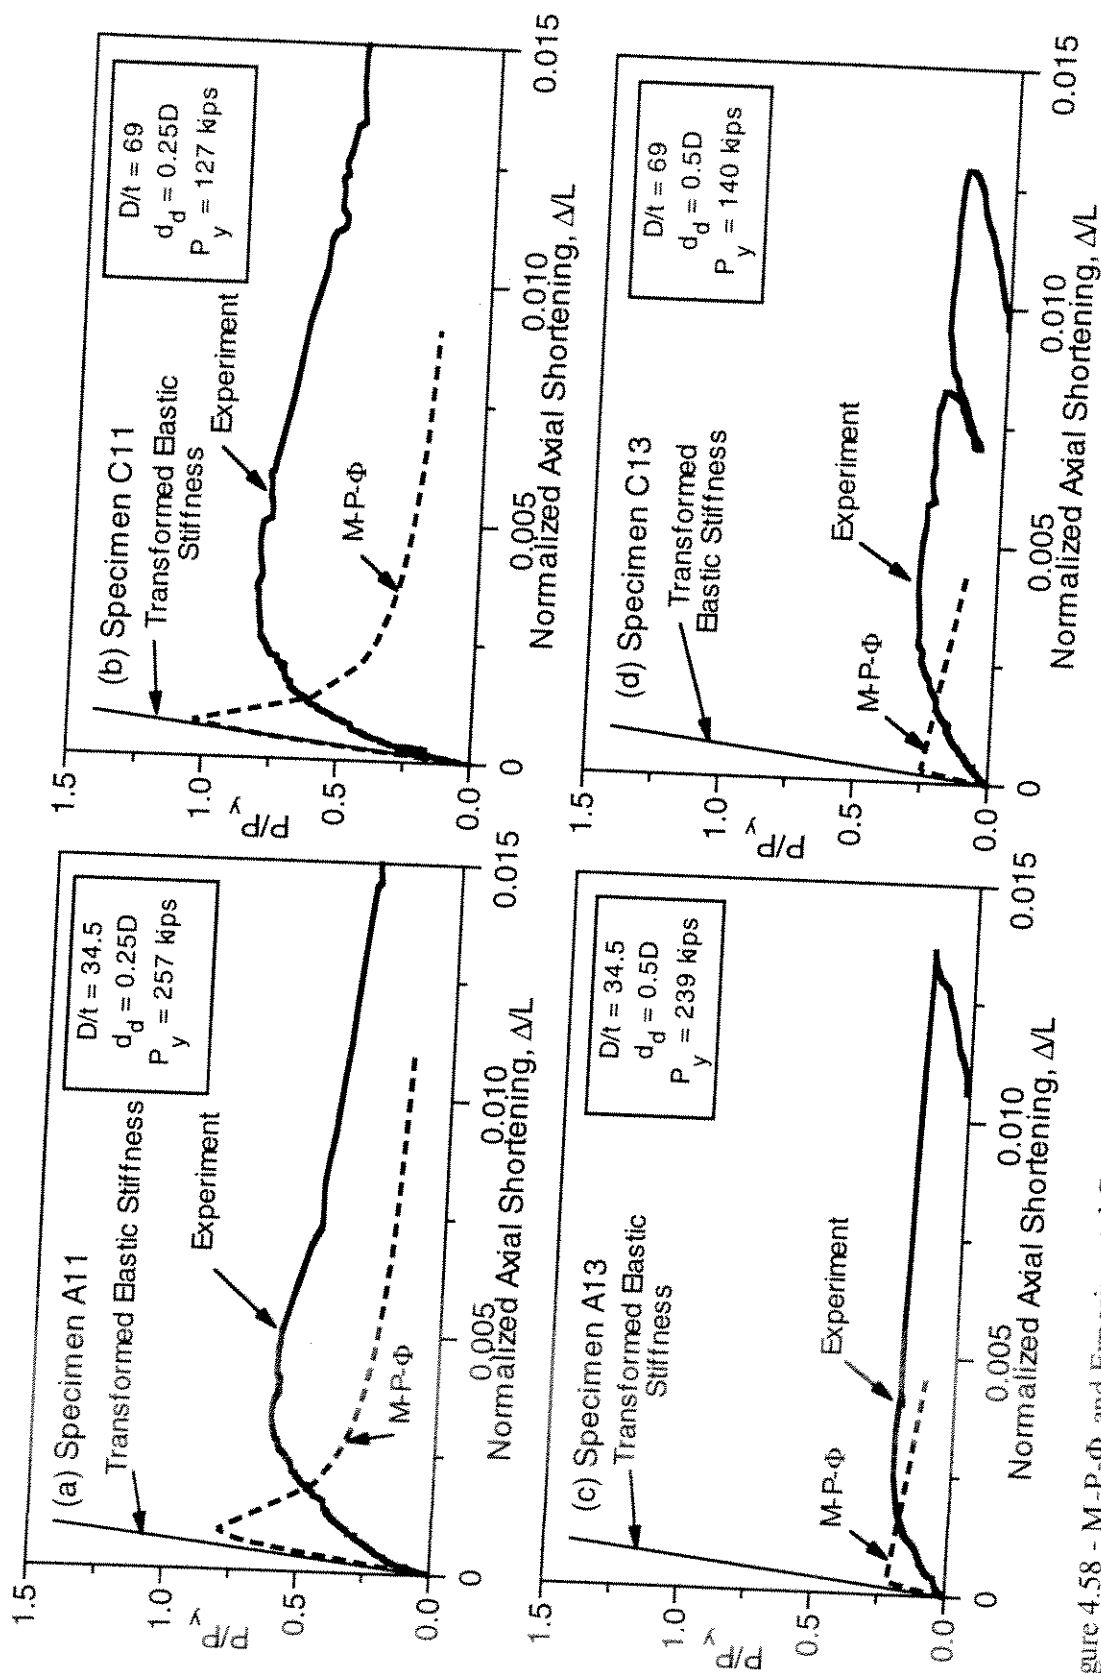
Figure 4.58 - M-P- $\phi$  and Experimental Comparison for the Axial Load-Shortening Response of Internal Grout Repaired Specimens  
(M-P- $\phi$  Analysis Based on Grout Modulus per Eqn (2.1))

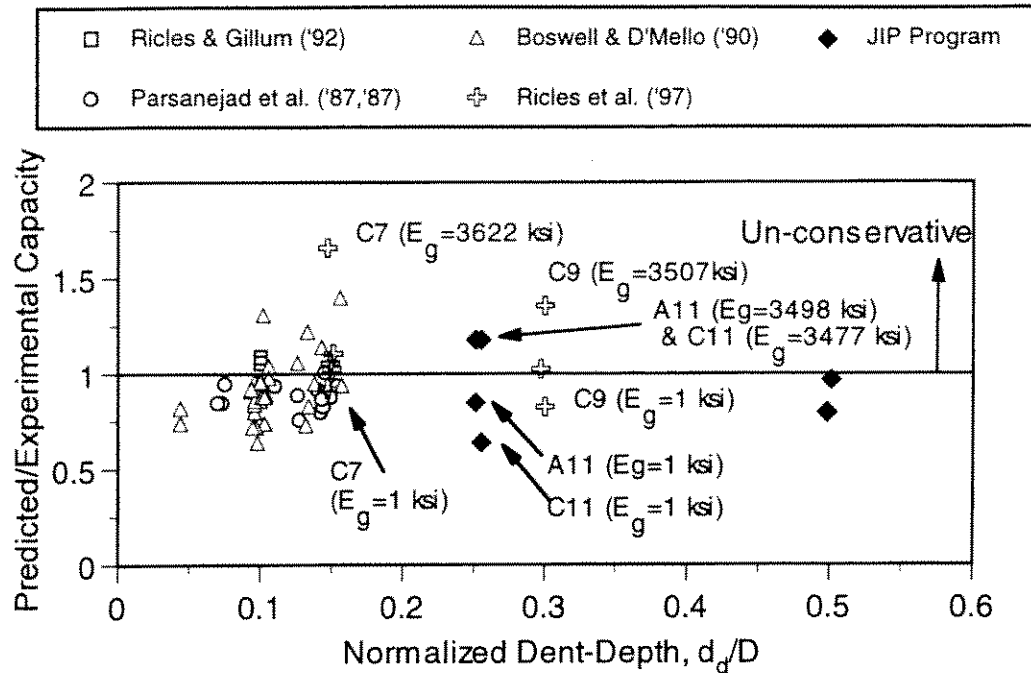
Figure 4.61 - Sensitivity of M-P- $\Phi$  Based Method to Depth of Applied Dent-Damage for Internal Grout Repaired Specimens

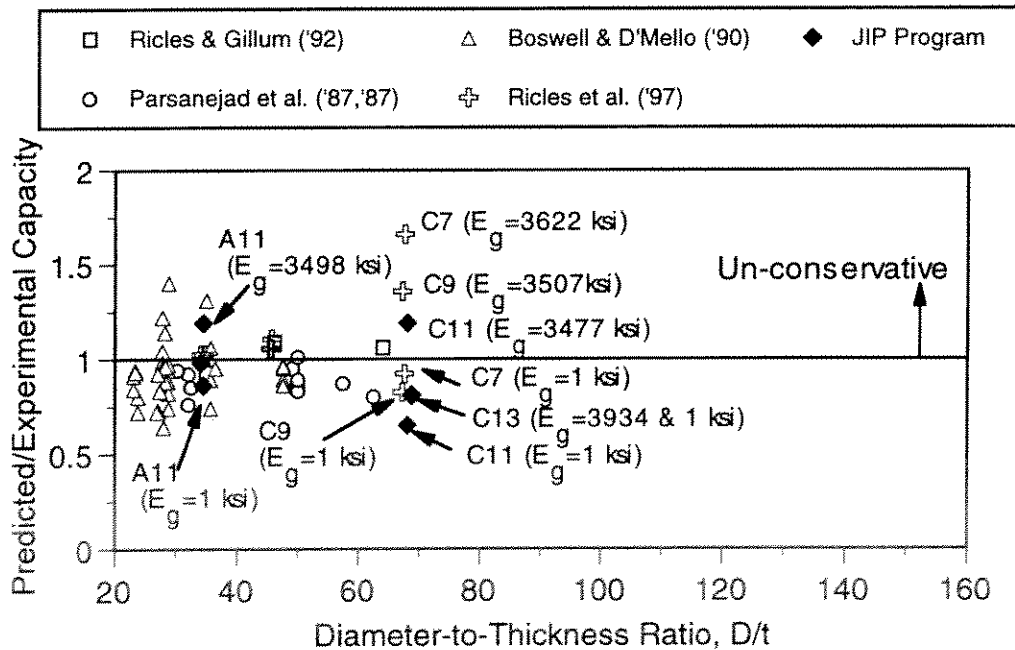
Figure 4.62 - Sensitivity of M-P- $\Phi$  Based Method to Diameter-to-Thickness Ratio for Internal Grout Repaired Specimens

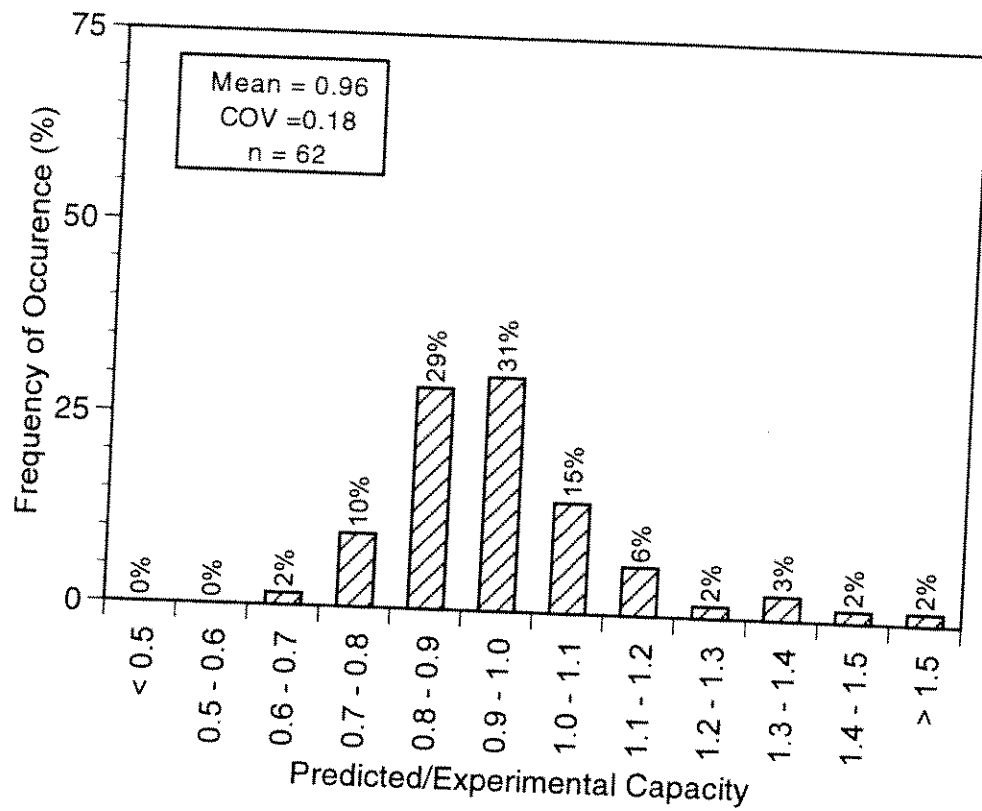
Figure 4.63 - Histogram of Predicted-to-Measured Capacity Ratio for M-P- $\Phi$  Based Method (Includes Previous Experimental Data)

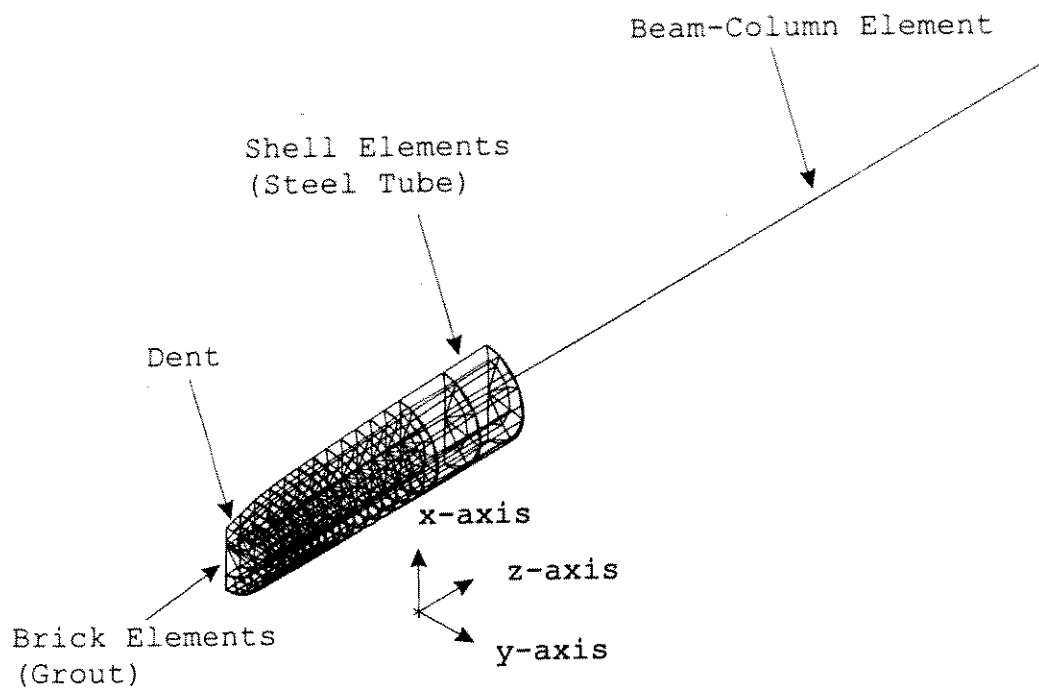
Figure 4.64 - Typical Finite Element Mesh for Internal Grout Repaired Specimens, Deformed Model Following Denting and Definition of Grout Elements (after Ricles et al. 1997)

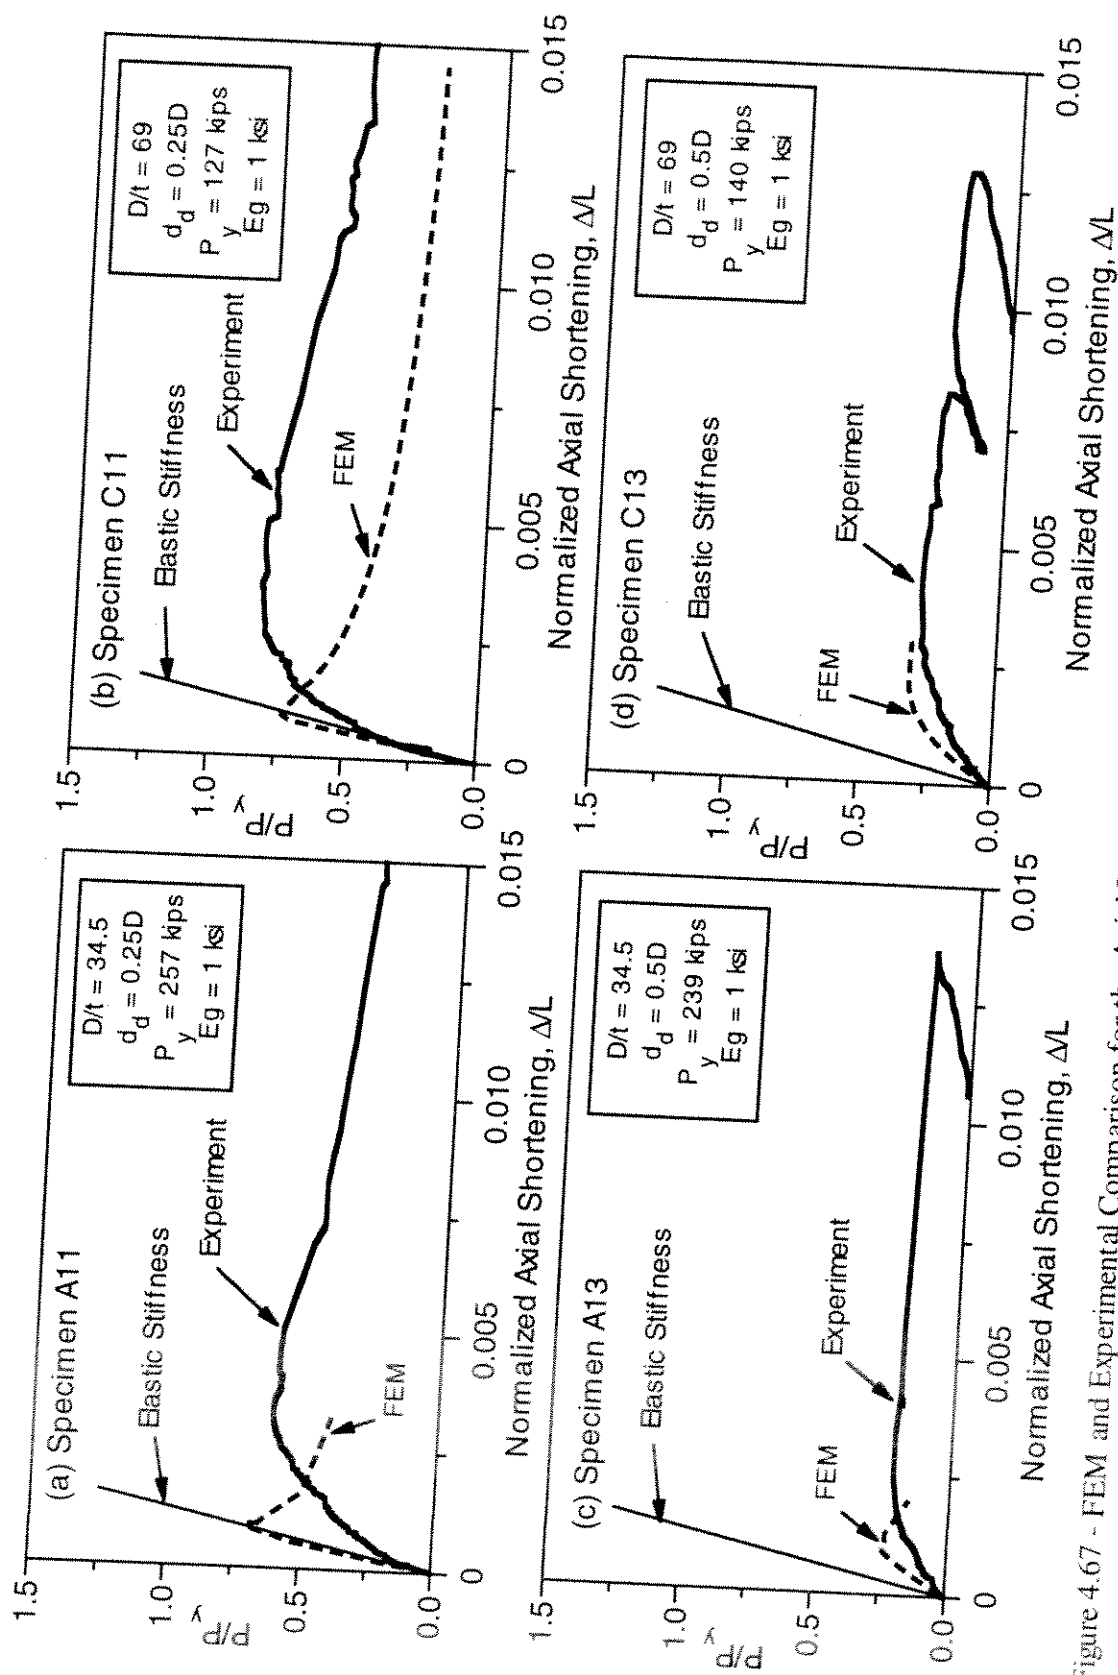
Figure 4.67 - FEM and Experimental Comparison for the Axial Load-Shortening Response of Internal Grout Repaired Specimens  
(FEM Analysis Based on Reduced Grout Modulus  $E_g = 1$  ksi)

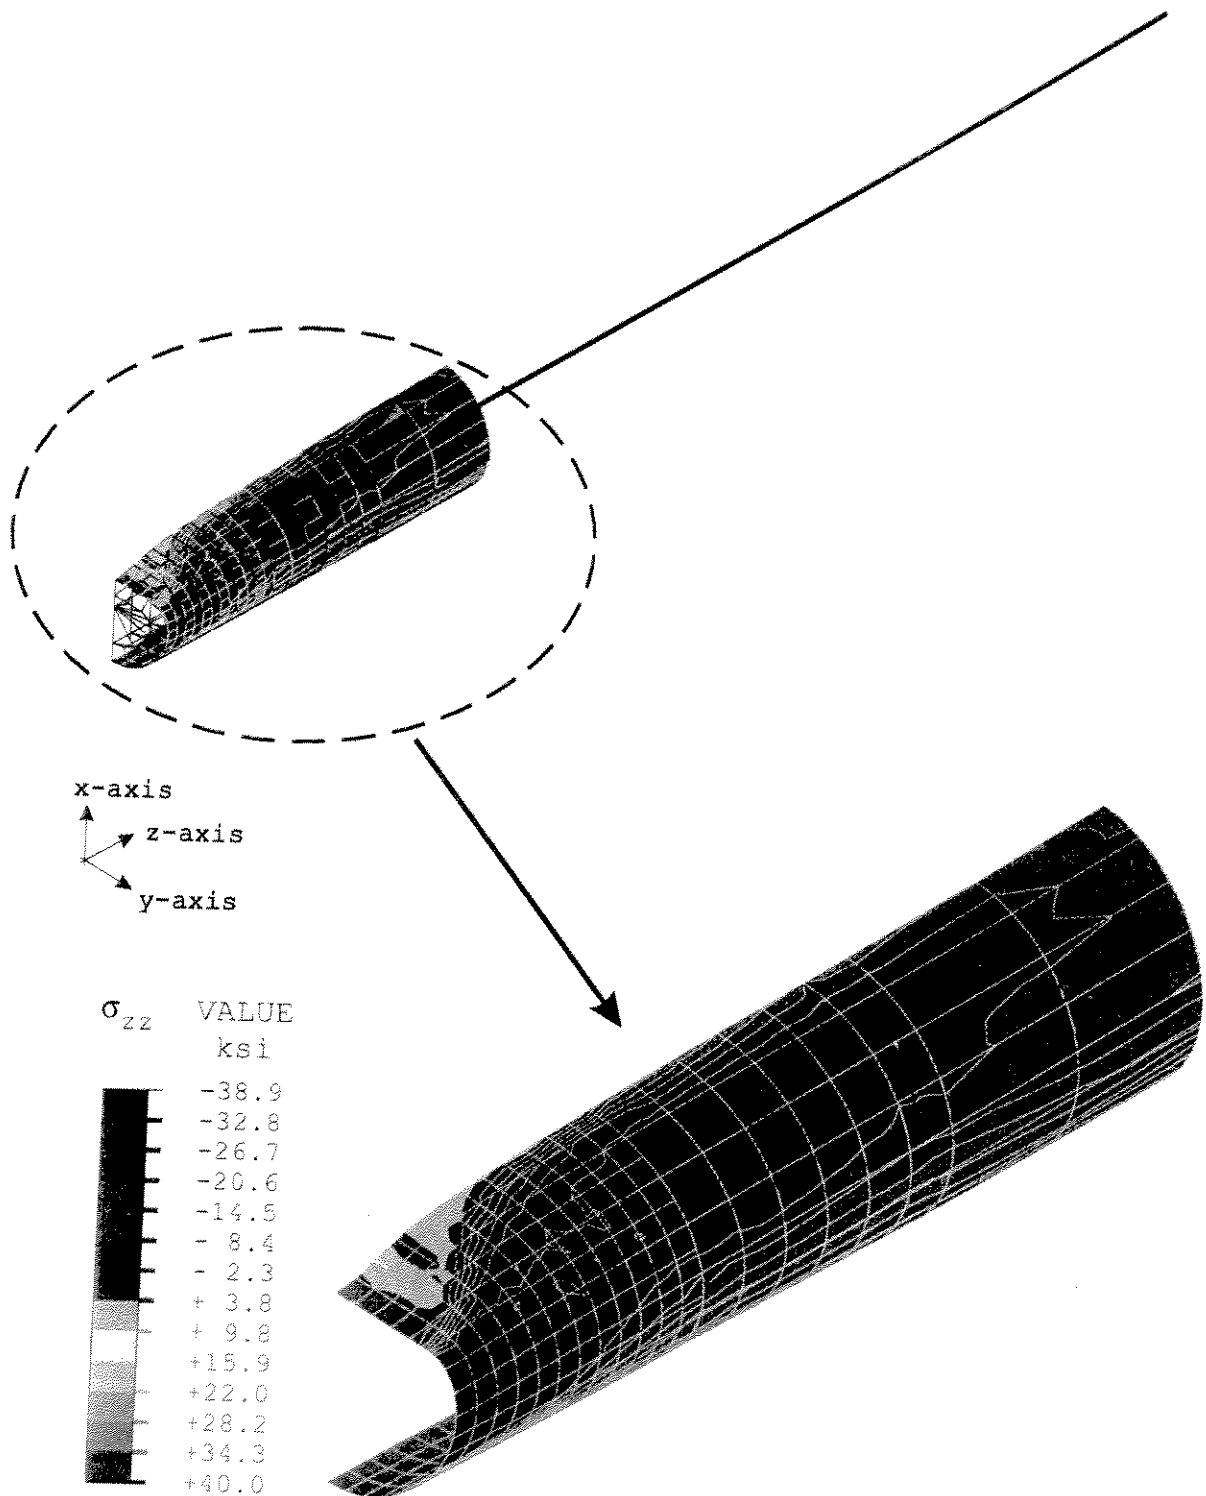
Figure 4.68 Longitudinal Stress Contour of Steel Tube of Specimen A11 Just After Maximum Axial Load in Analysis Was Achieved

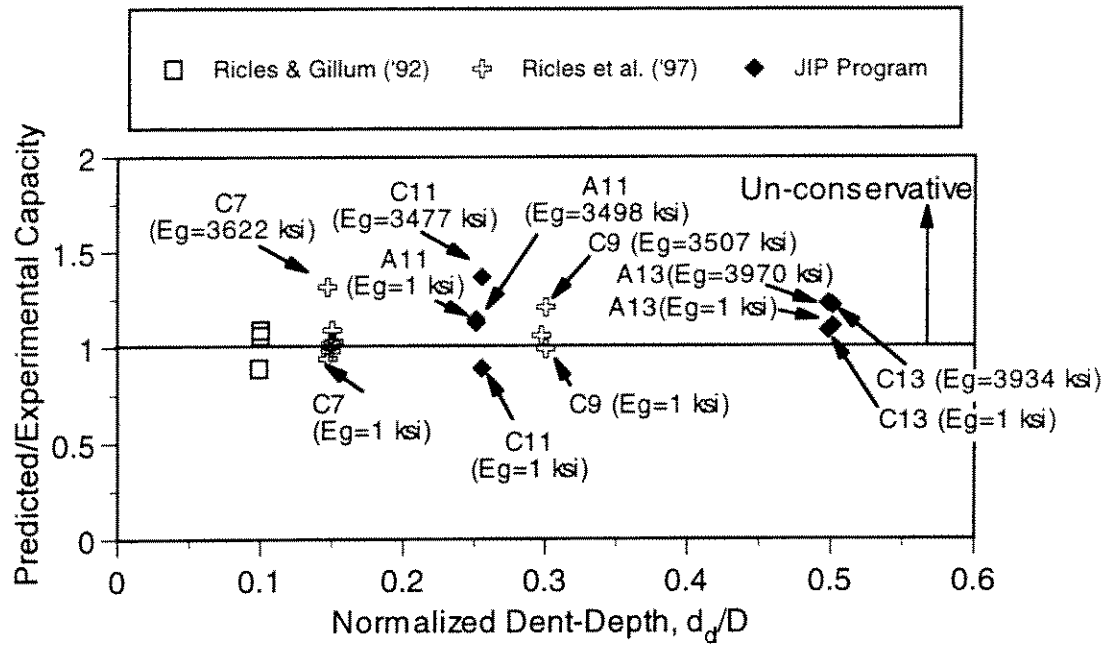
Figure 4.71 - Sensitivity of FEM Analysis to Depth of Applied Dent-Damage for Internal Grout Repaired Specimens

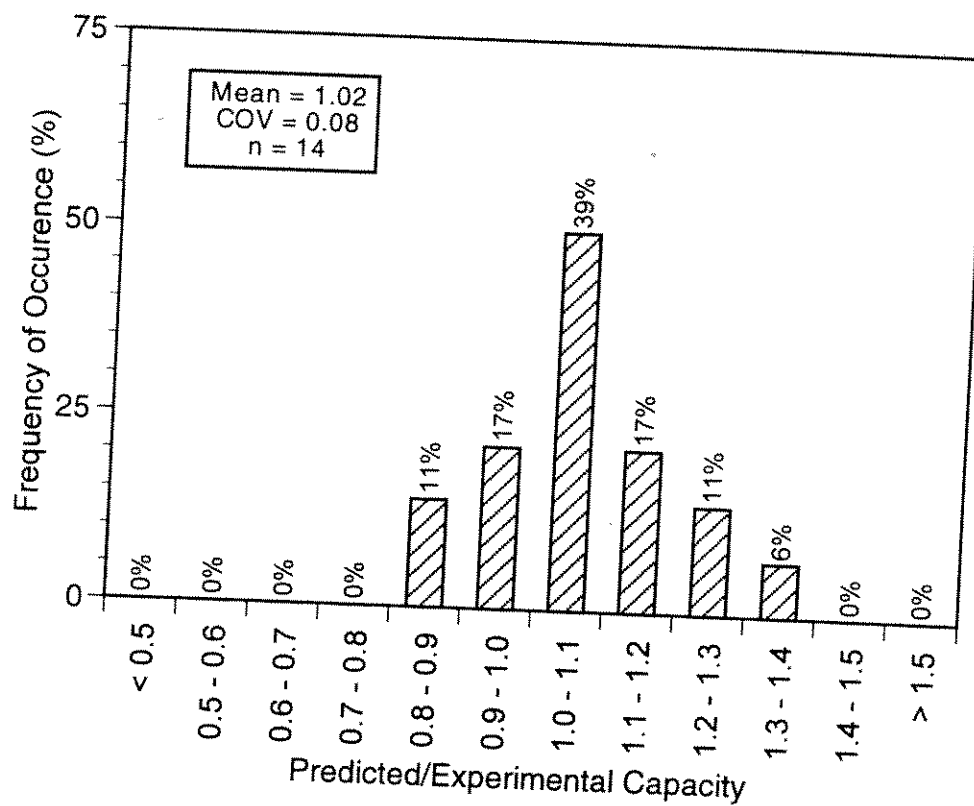
Figure 4.73 - Histogram of Predicted-to-Measured Capacity Ratio for FEM Analysis (Includes Previous Experimental Data from Ricles et al. ['92,'97], Analysis Based on Reduced Grout Modulus for Current Study)

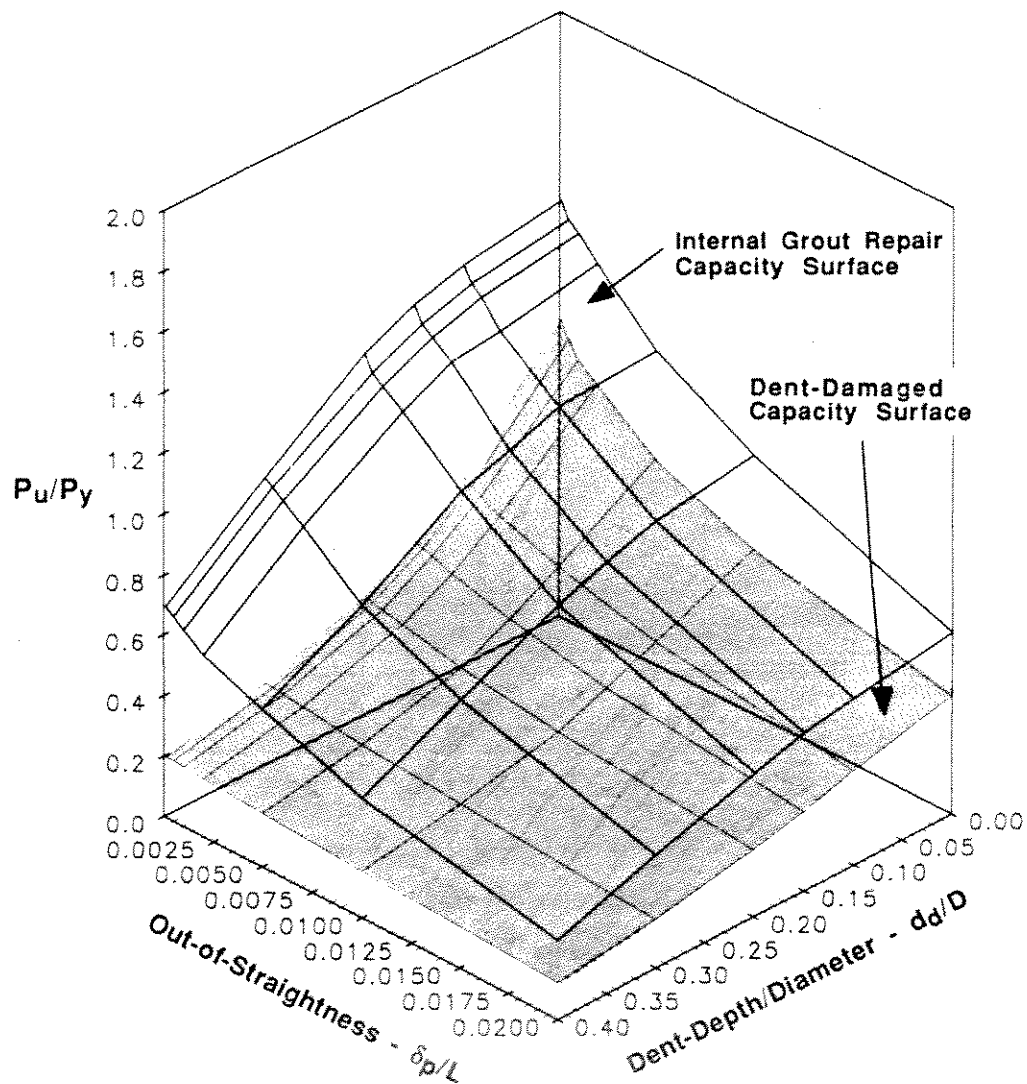
Figure 4.74 - Comparison of Residual Strength with Repaired Strength for  $kL/r = 60$  and  $D/t = 34.5$  ( $f'_g = 5.0$  ksi and  $\sigma_y = 34.8$  ksi) [after Ricles et al. 1997]

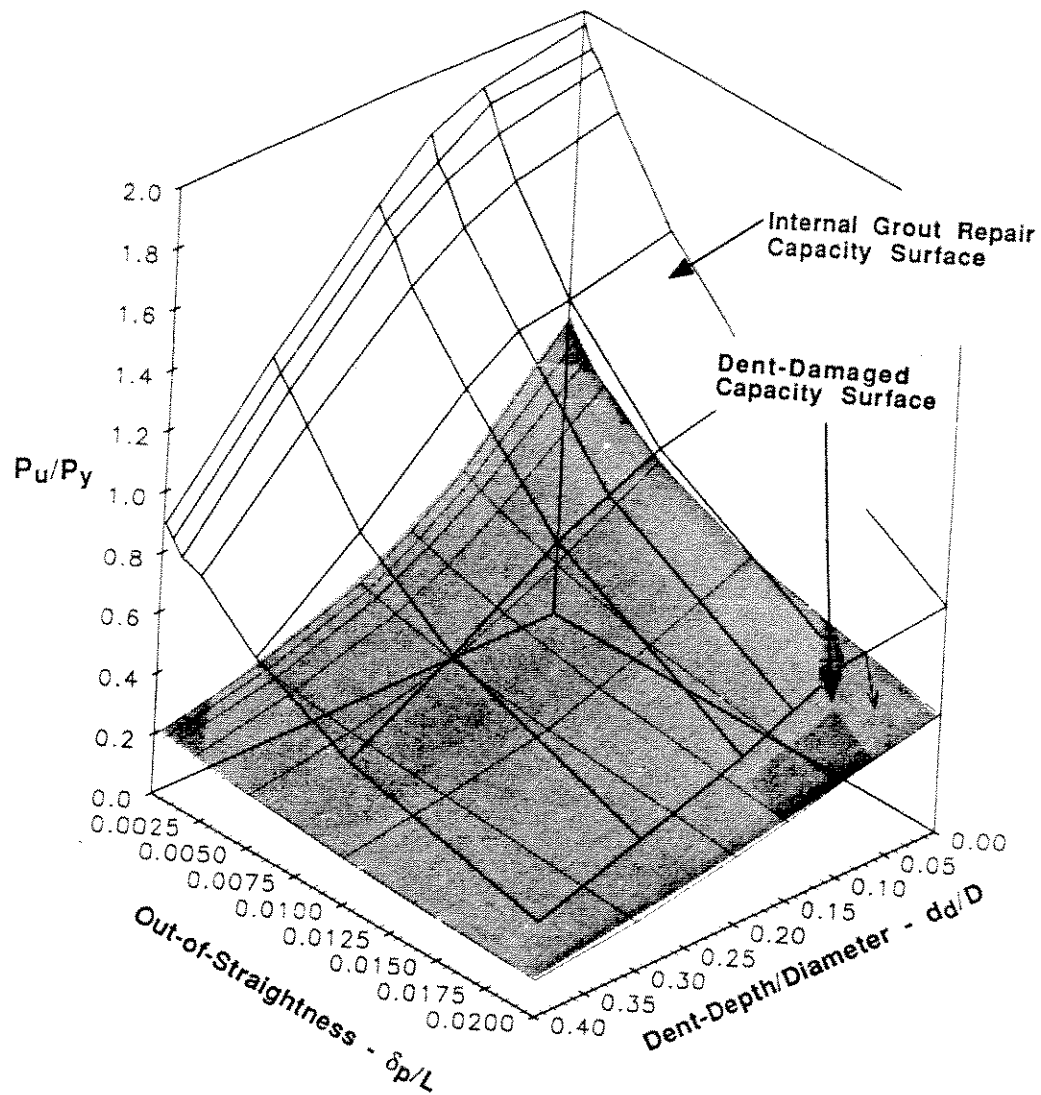
Figure 4.75 - Comparison of Residual Strength with Repaired Strength for  $kL/r = 60$  and  $D/t = 69$  ( $f'_g = 5.0$  ksi and  $\sigma_y = 34.8$  ksi) [after Ricles et al. 1997]

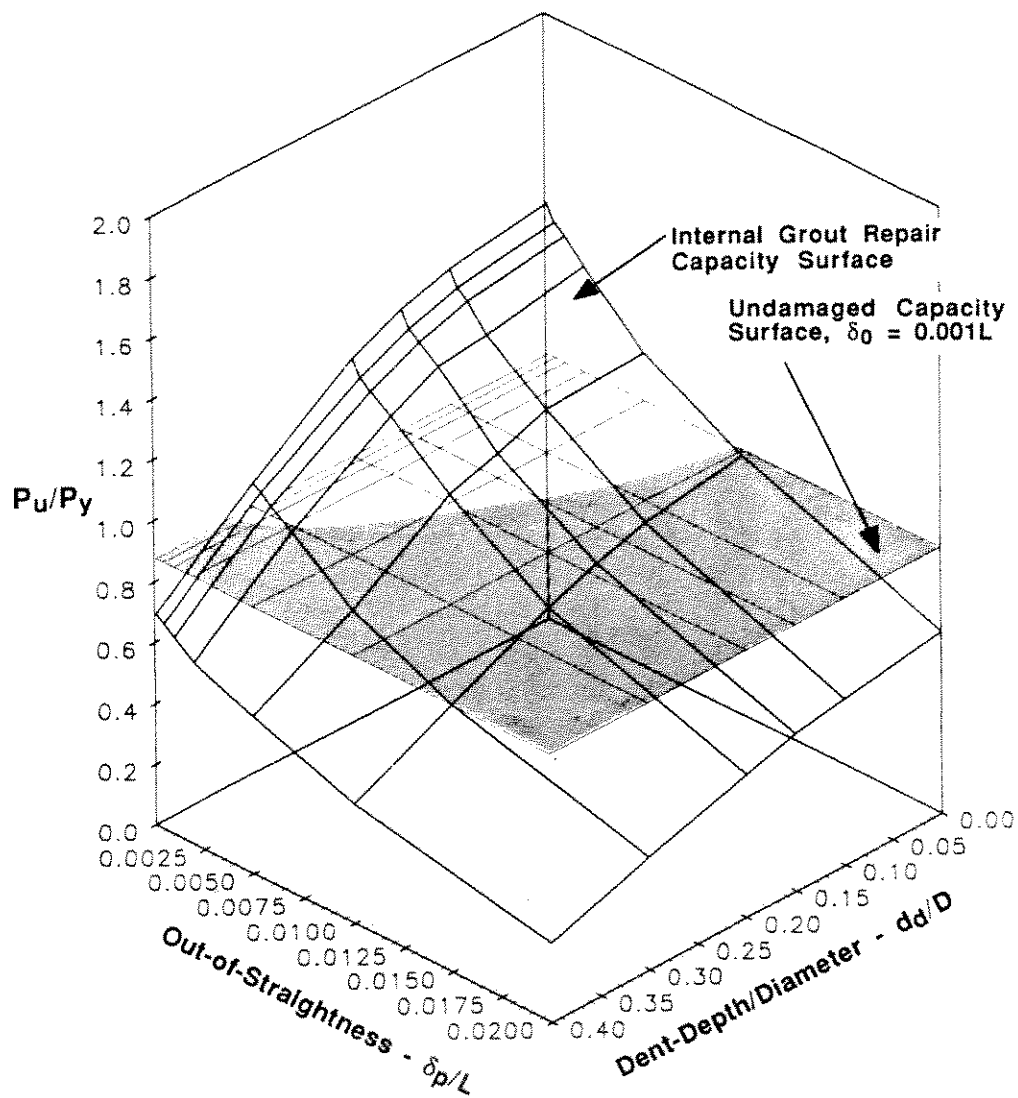
Figure 4.76 - Comparison of Residual Strength with Non-Damaged Capacity for  $kL/r = 60$  and  $D/t = 34.5$  ( $F_g = 5.0$  ksi and  $\sigma_y = 34.8$  ksi) [after Ricles et al. 1977]

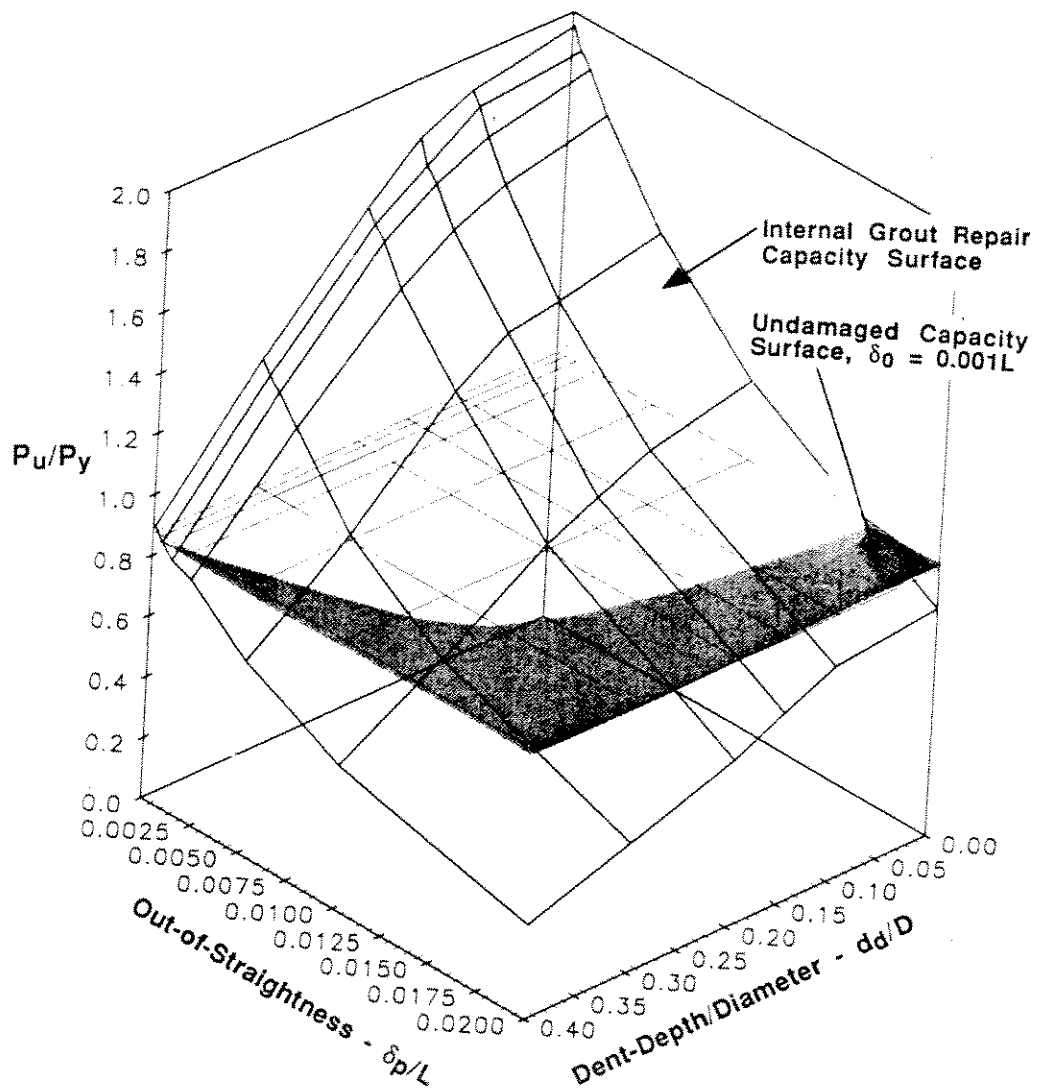
Figure 4.77 - Comparison of Residual Strength with Non-Damaged Capacity for  $kL/r = 60$  and  $D/t = 69$  ( $F_g = 5.0$  ksi and  $\sigma_y = 34.8$  ksi) [after Ricles et al. 1977]

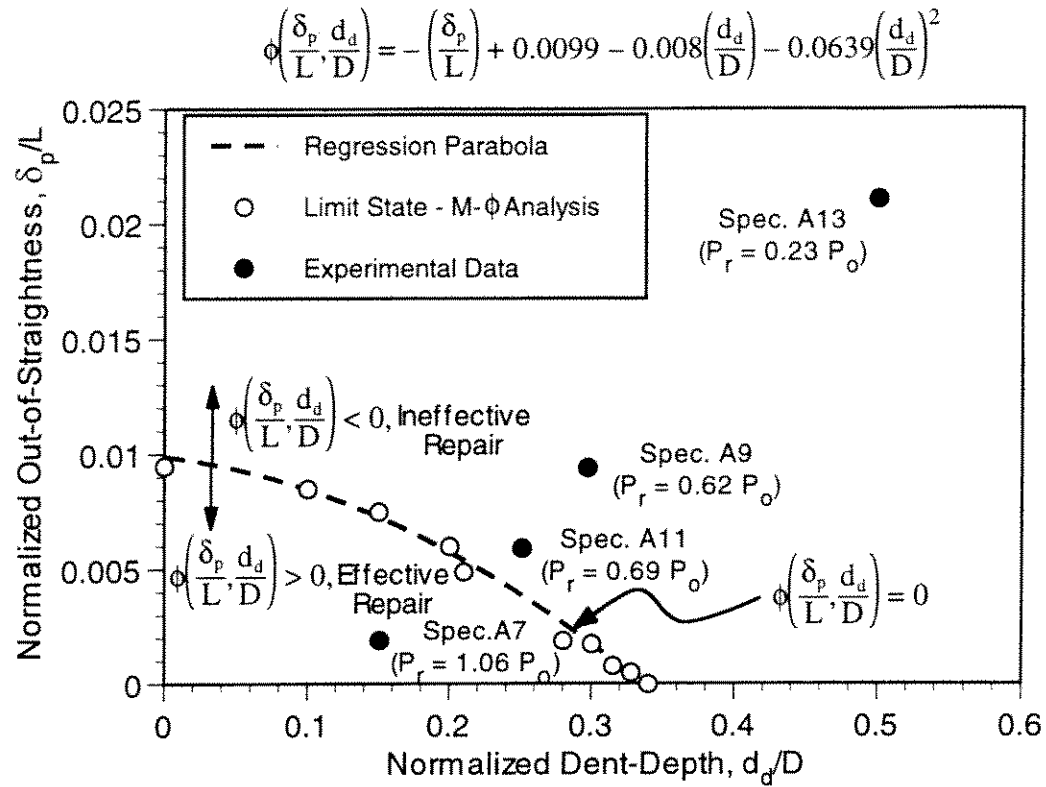
Figure 4.78 - Regression Analysis Showing the Limit of Repairability by Internal Grouting of Dent-Damaged Members with  $D/t = 34.5$  and  $KL/r = 60$

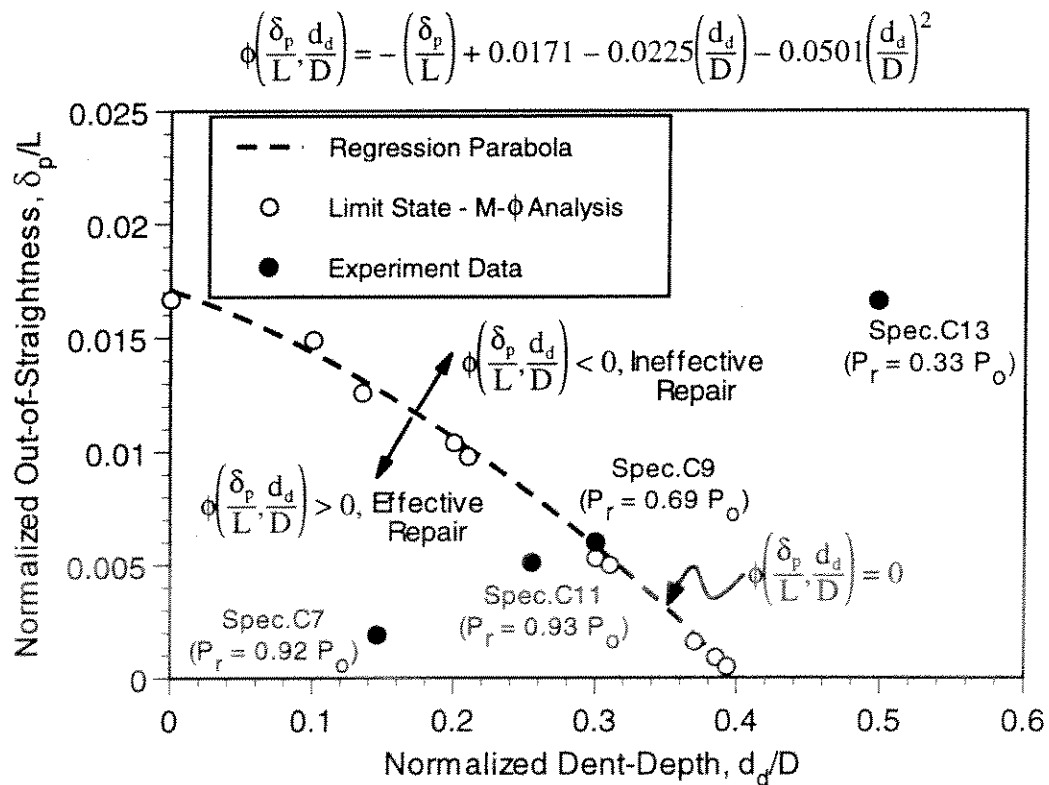
Figure 4.79 - Regression Analysis Showing the Limit of Repairability by Internal Grouting of Dent-Damaged Members with  $D/t = 69$  and  $KL/r = 60$
